6444058

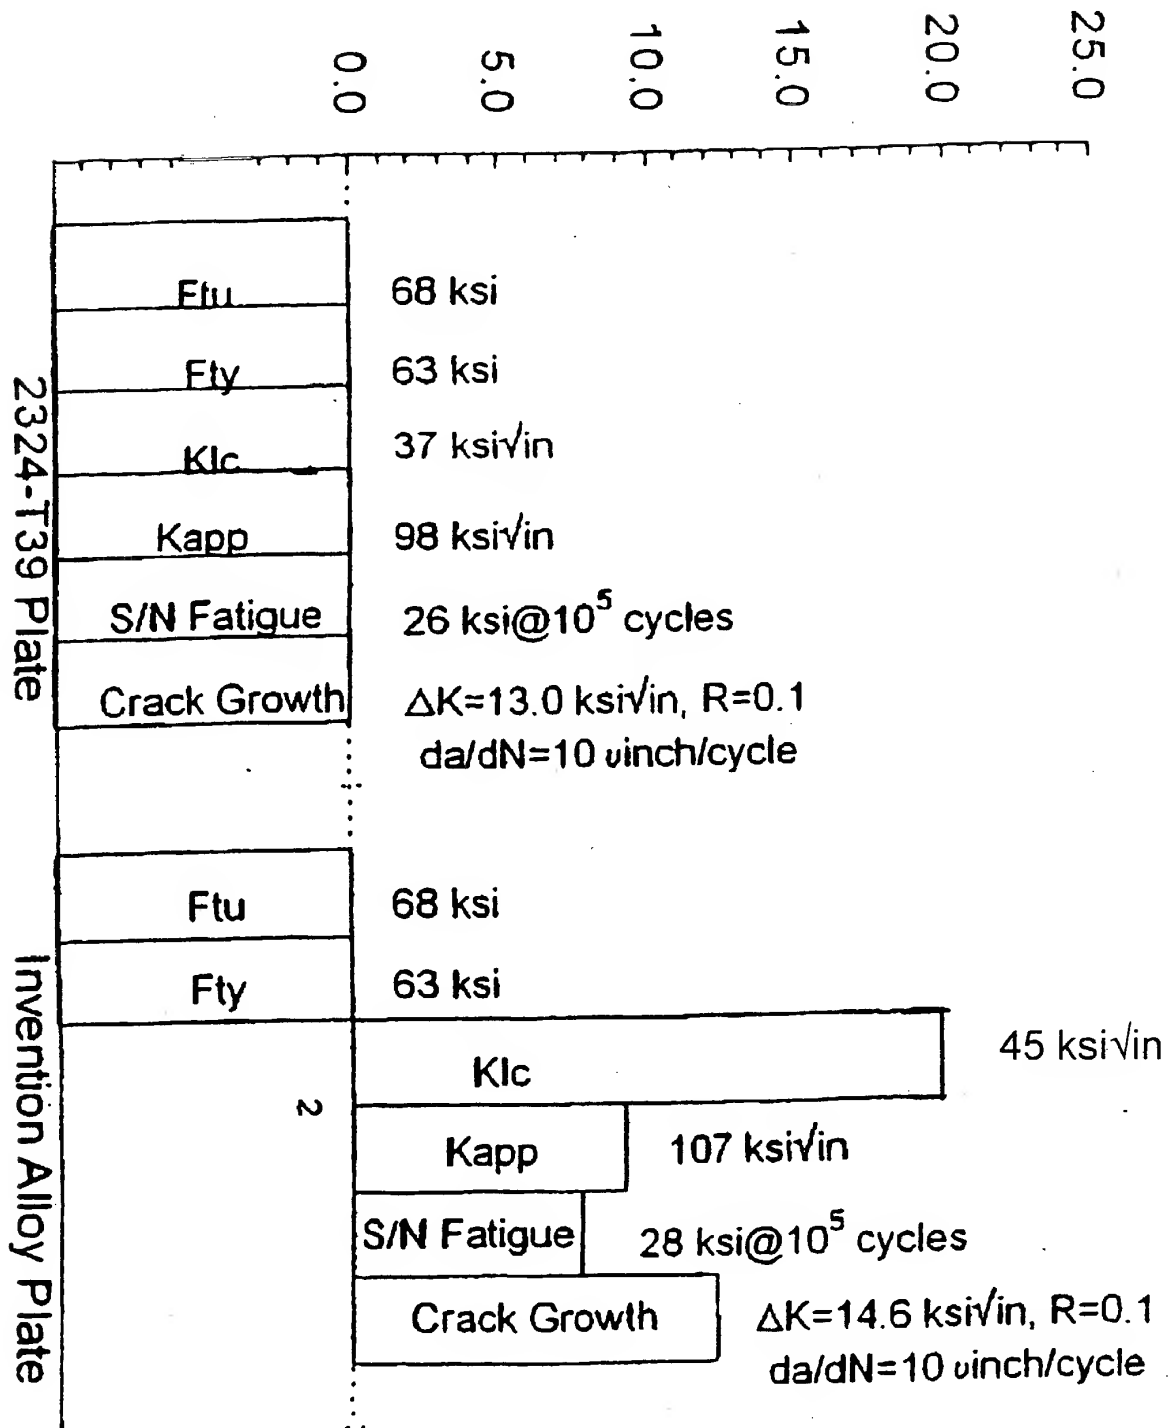
FIGURE 1

% Change in Property

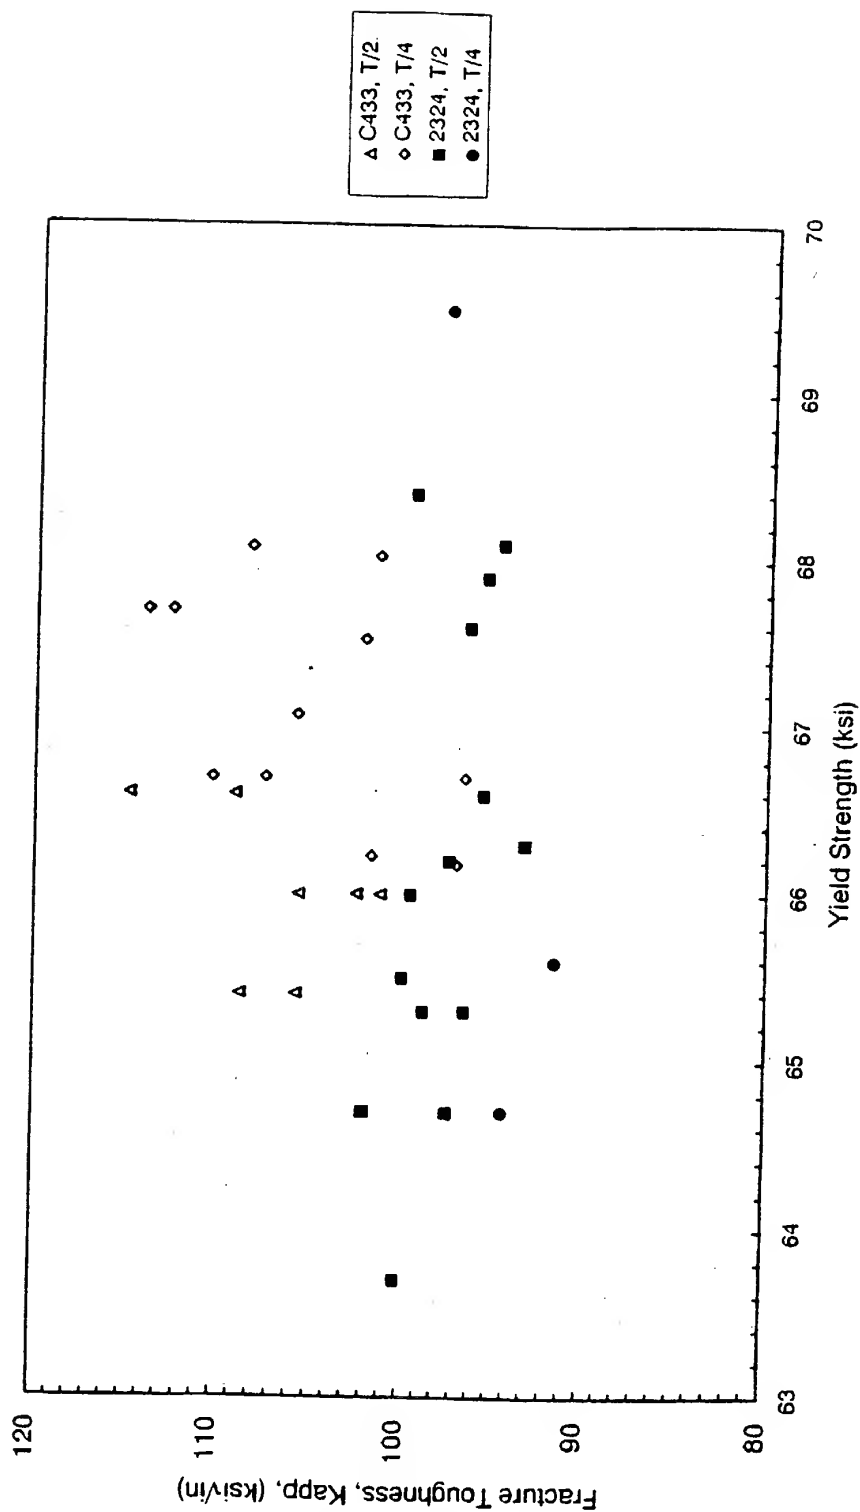
Fig. 4

Plane Stress Fracture Toughness (K_{app}) of C433-T39 and
2324-T39 Plate in L-T Orientation

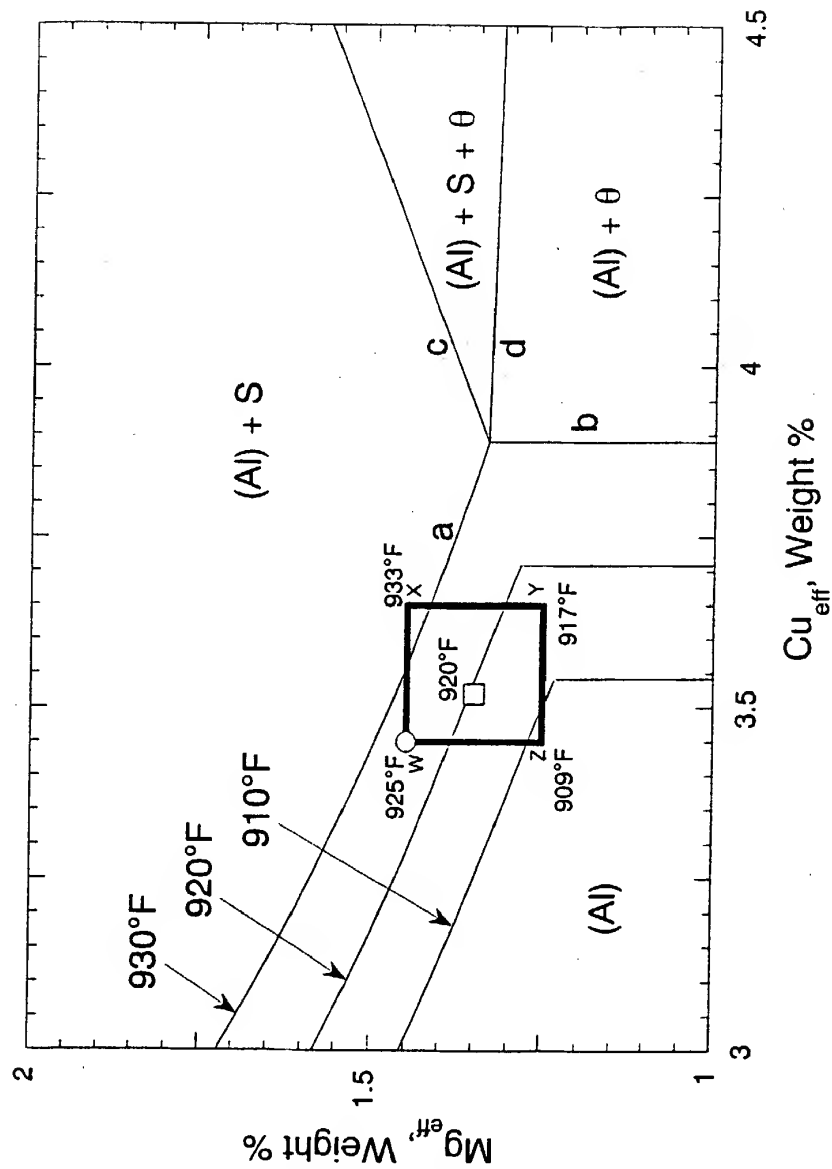
Fig 5

Solvus Boundaries in Al-Cu-Mg System
